Scrutineers' Bulletin

July 2021 – 188

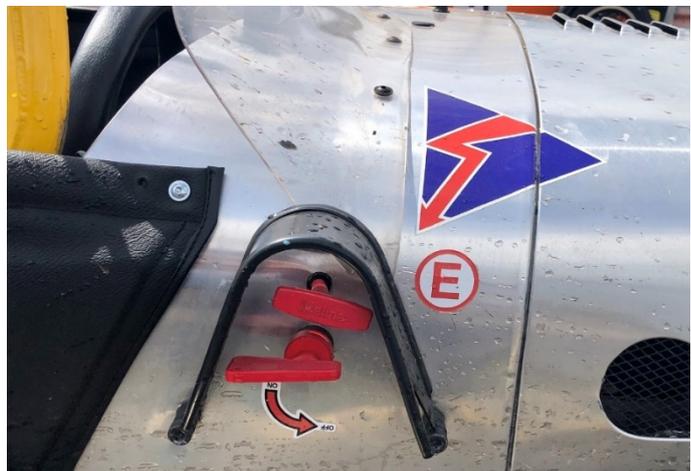
This photo depicts an external cut-off and extinguisher switch installation with both good and bad elements. The first thing to note is that the electric cut-off switch has been marked with an arrow to indicate which way to turn it in an emergency – good practice, and something that might just save a vital split-second on the arrival of a marshal to the scene of an incident. At a glance then this installation seems to be very good – however, when you look closer it is quite the opposite.

Look at the two stickers top right of the switches – yes, the extinguisher label is probably too small, but this could be easily corrected. But when you look at the stickers in relation to the switches it soon becomes apparent that they are the opposite way around. The extinguisher switch is at the top, but the extinguisher label is at the bottom.

The consequences in the case of emergency attendance at the vehicle could be serious, with the extinguisher being set-off when it is intended to cut-out the electrics or vice-versa.

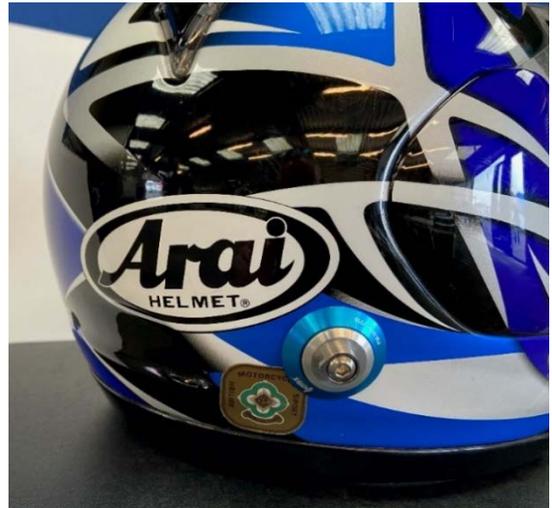
We were sent this photo of a helmet presented for use, and which was correctly identified as non-compliant. As can be seen in the photo, the helmet bears an 'ACU Gold' sticker for motorcycle sport use. This is not a recognised standard for motorsport use.

There was no other standard label (Snell/FIA) on the helmet that may have made it eligible for use. Interesting also to note that the helmet has been retrofitted with Frontal Head Restraint anchorage posts, which indicates that the owner intended it for continued use in motorsport.

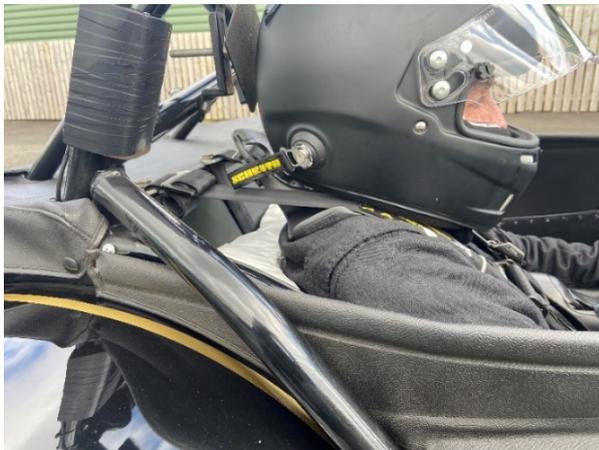
This first image was sent to us and demonstrates an incorrect harness routing for use with a Frontal Head Restraint. Correct harness routing and positioning is a vital part of the use of an FHR, and it is important that when using one the harness shoulder straps are not routed at an angle above the horizontal.

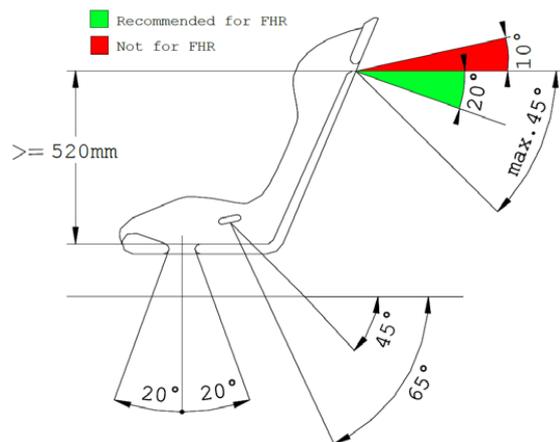
The ideal routing for the shoulder strap is within the horizontal and up to 20° below, as demonstrated in the diagram above (drawing K39 in the Yearbook).

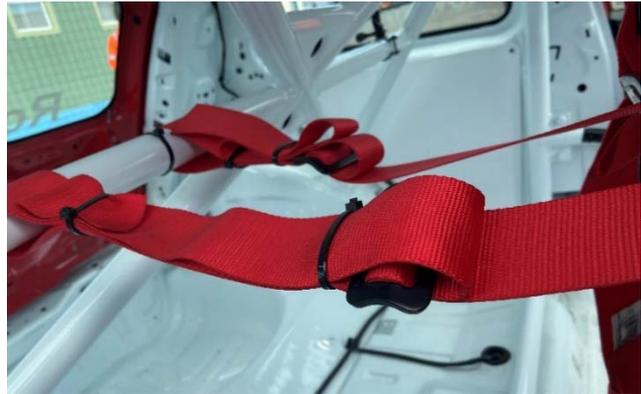
This first example fails in more than one area. Firstly, the 3-bar slide should be located as close as possible to the harness bar, but you can see that this is not the case, especially for the strap closest to the camera. Secondly, once the position and length are set, the remaining length of harness webbing should be passed back through the 3-bar slide to properly secure it from any potential slippage. In this case it has simply been folded over the top and held in place with cable ties.

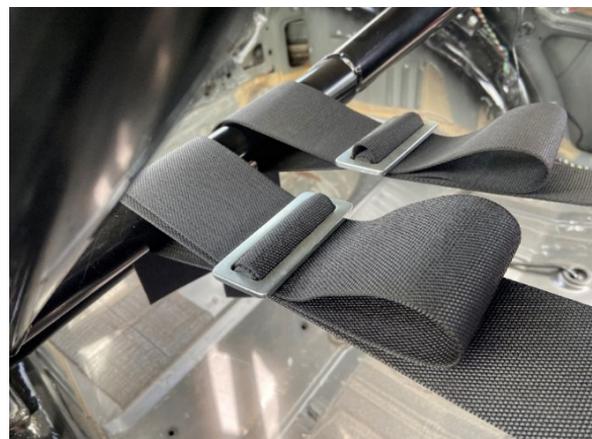
This next example is a much neater installation, and the 3-bar slide is positioned suitably close to the harness bar. However, one fundamental mistake has been made, and that is passing the remaining length underneath-over-underneath the 3 bars.

With this incorrect routing, if the free end of webbing were pulled with enough force, it could release enough to cause the harness installation to be ineffective. This one was well spotted.

The correct routing would be to pass over the top of the first 2 bars and then underneath the 3rd as shown in the diagram and correct photo below.

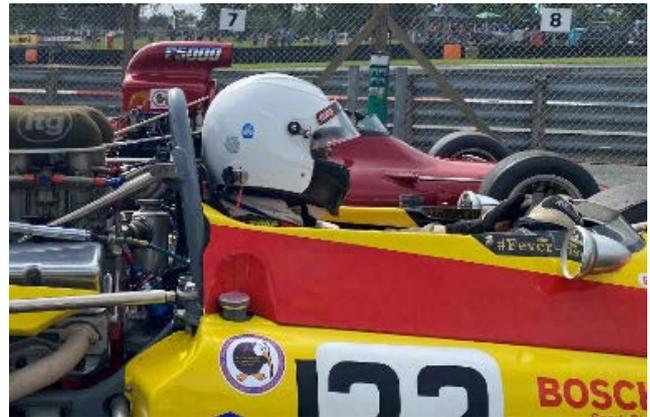
The photo here demonstrates an incorrect ROPS height on a single seater car with the driver seated. As can be clearly seen, the top of the helmet is significantly higher than the top of the ROPS hoop, which could have potentially serious consequences in the case of vehicle inversion.

Please do make sure to take the opportunity to check ROPS height with the driver seated wherever possible, as without doing so something like this would be very difficult to spot.

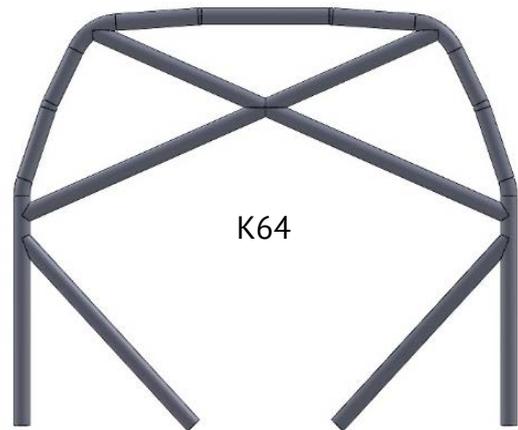
P57.1.4. A Vehicle Passport is required for any existing vehicle fitted with diagonal members forming a high cross as shown in Drawing K64. Vehicle Passports for these vehicles must be obtained by 1st January 2022, after which no further vehicles with such a design will be approved.

It should be noted that the installation of diagonal members in the form of a “high cross” has not been permitted in Cross Country regulations. This new regulation provides retrospective approval following two assessments by separate and independent engineers. The issue was identified with a small number of imported vehicles from France and further investigation identified a small number of UK built vehicles, some of which have been competing for a couple of decades without this being identified. Whilst the assessments calculated that the “high cross” installation passed the minimum thresholds this design is marginally less effective which is why there is no provision made for future approvals.

Competitors who need to arrange for a vehicle inspection for Vehicle Passport should contact Joe Hickerton in the Technical Department who will assist: Joe.Hickerton@motorsportuk.org
